February 1944 as
Advance Restricted Report 4B02

FLIGHT TESTS OF THE THERMAL ICE-PREVENTION
EQUIPMENT ON THE B-17F AIRPLANE

By Bonne C. Look

Ames Aeronautical Laboratory
Moffett Field, California

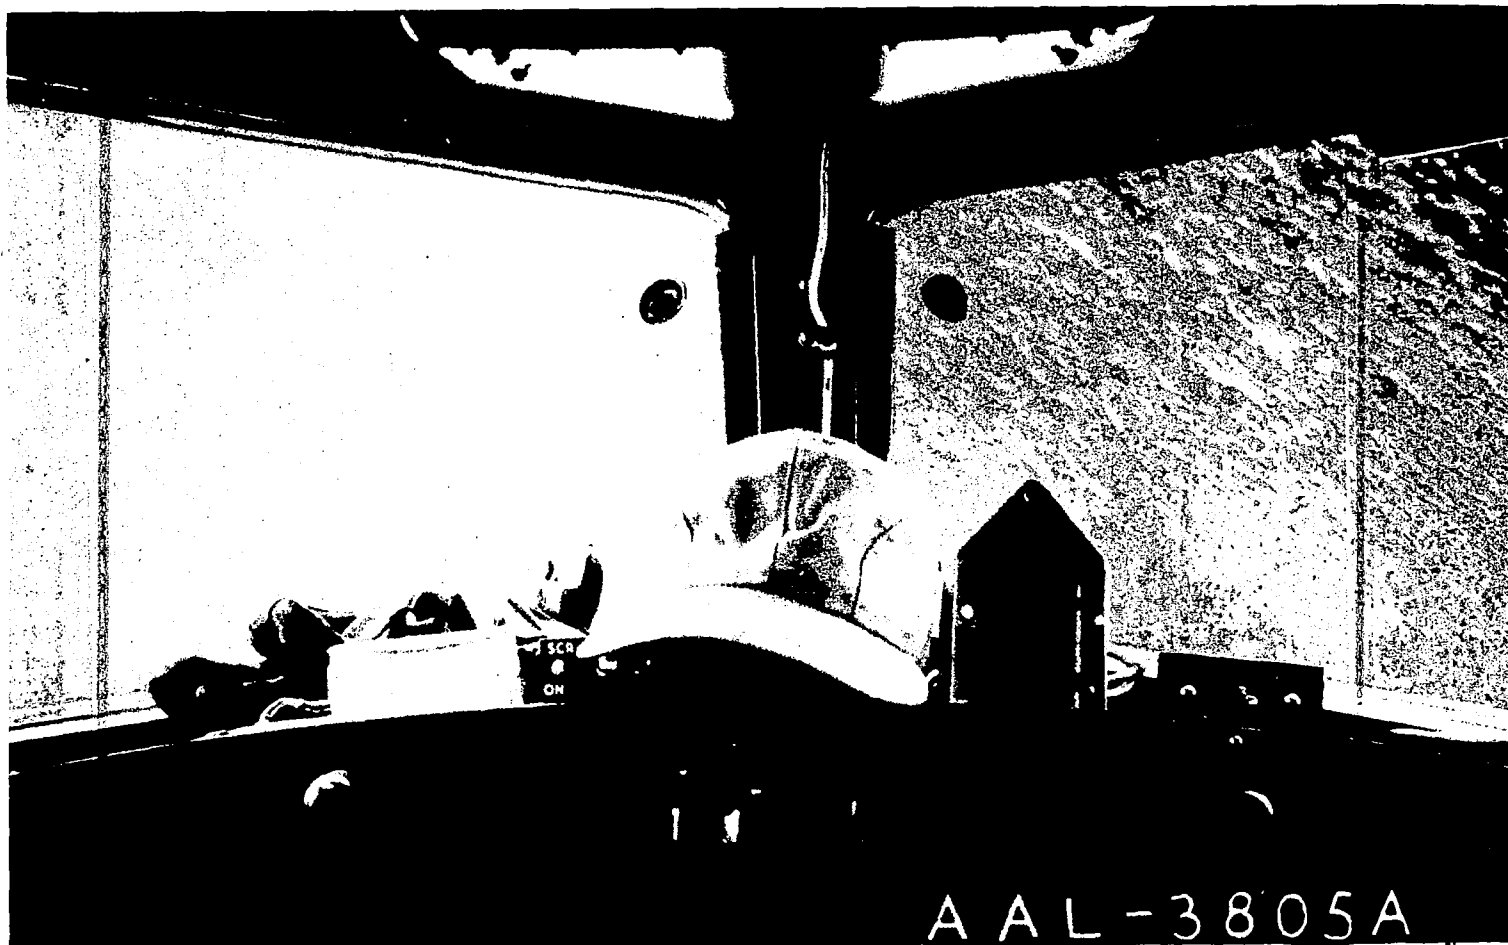
Figure 34.- The pilot's (left) and copilot's (right) windshields during tests 4 and 5, after leaving the icing region. The heated pilot's windshield is clear of ice.

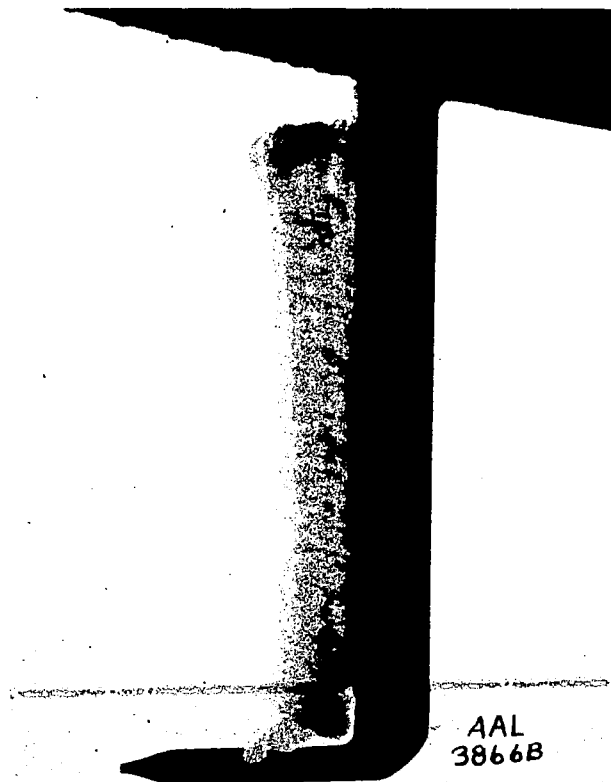
The severity of icing on the airspeed-head support mast is shown in figure 44. This figure is a photograph of the right airspeed-head mast taken at the same time figure 43 was obtained. The static-pressure openings in the airspeed head are located about $2\frac{1}{2}$ inches forward of the support-mast leading edge. The ice accumulation shown in the figure extended to within $1/8$ of an inch from the static openings, and is an example of the ice formation accumulated during many of the flights. An accumulation of this magnitude was found to affect the airspeed reading as much as 20 miles per hour at cruising-power conditions.

Figure 44.- Ice accumulation on the right airspeed mast during test 7. (Photograph taken after landing.)
